Chapter 6 Alternatives

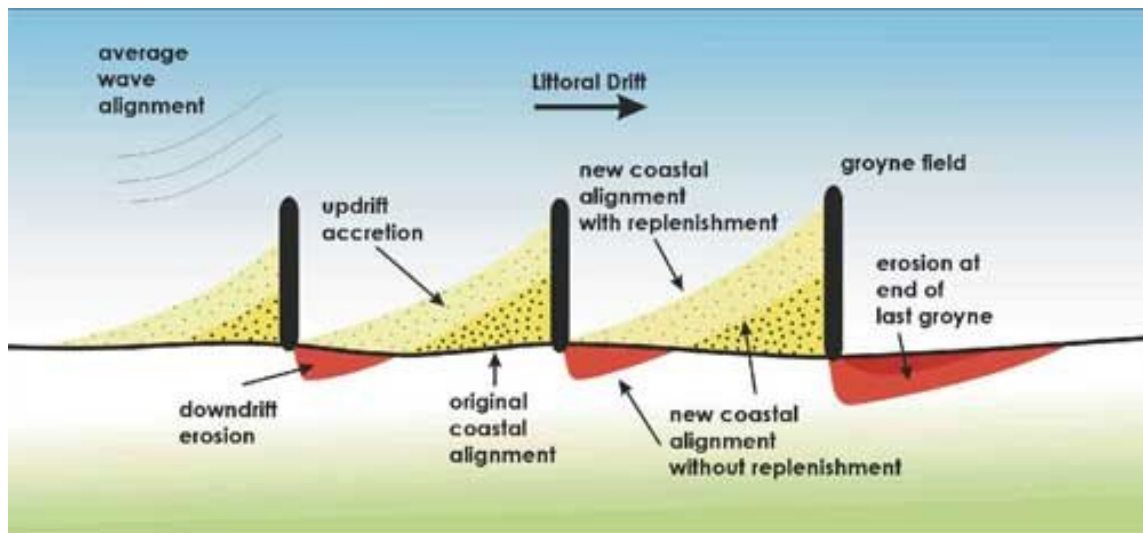
A groyne is a narrow structure projecting from the shoreline to the nearshore at approximately right angle (i.e. perpendicular to the shore). Groynes can be installed parallel to each other and can come into a variety of shapes and can be constructed with different materials like stone and masonry. The main intent of using groynes to control erosion at a site is to trap some or all of the material being transported along the shore. The materials are usually trapped on the updrift side of the groyne.

Figure 6.1.: Schematic of Groynes. Source: www.environment.sa.gov.au

The erosion at the present site is being caused primarily by the hydrodynamics created by the wall and a groyne as per the definition and use given above would not be suitable for the site even though there are good resemblances to the proposed structure. The primary objective of the proposed structure is to limit to a maximum the hydrodynamics caused by the wall and entrapment of materials would be a secondary effect expected. The length of shoreline available for intervention is also too short to allow for a series of groynes to be placed to ensure entrapment of the materials within the region of concern. In addition, the fact that the wave attack, during extreme events, at the site would be mainly from the north and north west, any materials accumulated between the groynes would be emptied.

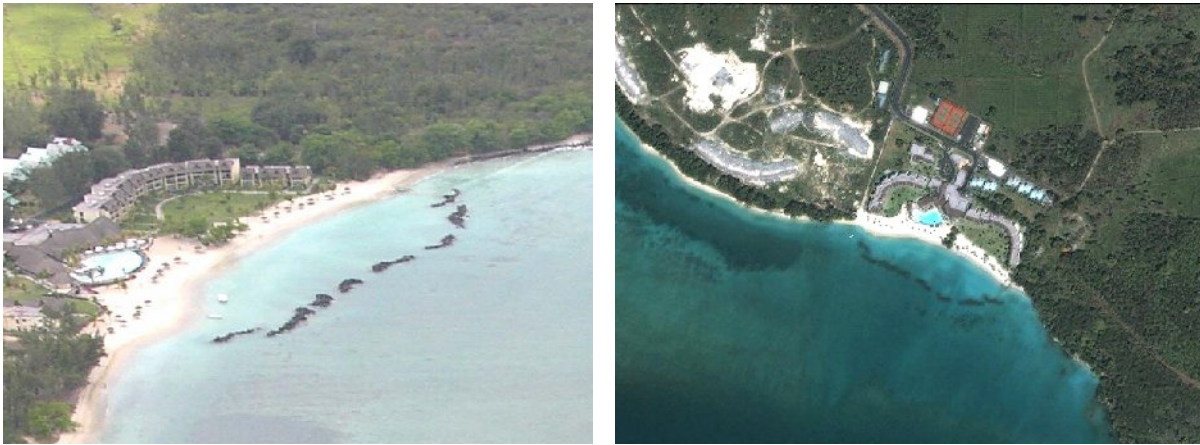
Detached breakwaters are structures that are constructed at a considerable distance and parallel to the shore and are not connected to the shore by any sand-retaining structure. Detached breakwaters can be constructed as a single continuous structure or a series of structures interspaced with gaps.

Unlike groynes which trap materials from the longshore current, detached breakwater have for main effect to create an area of reduced wave energy on the leeward side of the structure by dissipating, diffracting and reflecting the incoming waves. A reduction in the wave energy would usually result in a reduction in the currents and the sediments are thus more prone to be deposited and accumulated. Usually detached breakwaters are more effective where sediments are transported cross-shore.

Picture 6.1. (a) & (b): Aerial and satellite image of detached breakwaters in front of The Sands Resort
Source Aerial from Baird 2003, Satellite from Flash Earth

Detached breakwaters have been considered in the present case and have been turned down for the following reasons

- The detached breakwaters would have been located some 200 m from the shoreline and would thus require heavy machinery over an extended area of the lagoon. This would have had detrimental effects on the habitat.
- The detached breakwaters would reduce the waves reaching the wall and thus diminish the current created but there would still be a current flow along the wall.
- The detached breakwaters would be placed directly opposite to the wall and thus in front of neighbouring sites and this could probably be viewed as aesthetically incorrect and unnatural.
- The detached breakwaters may hinder navigation within the lagoon
- The amount of materials, such as rocks and boulders, needed is relatively much higher than the proposed structure and is thus more expensive to put in place.
- Reaching such distances with heavy machinery may cause lost of damage to the marine environment.

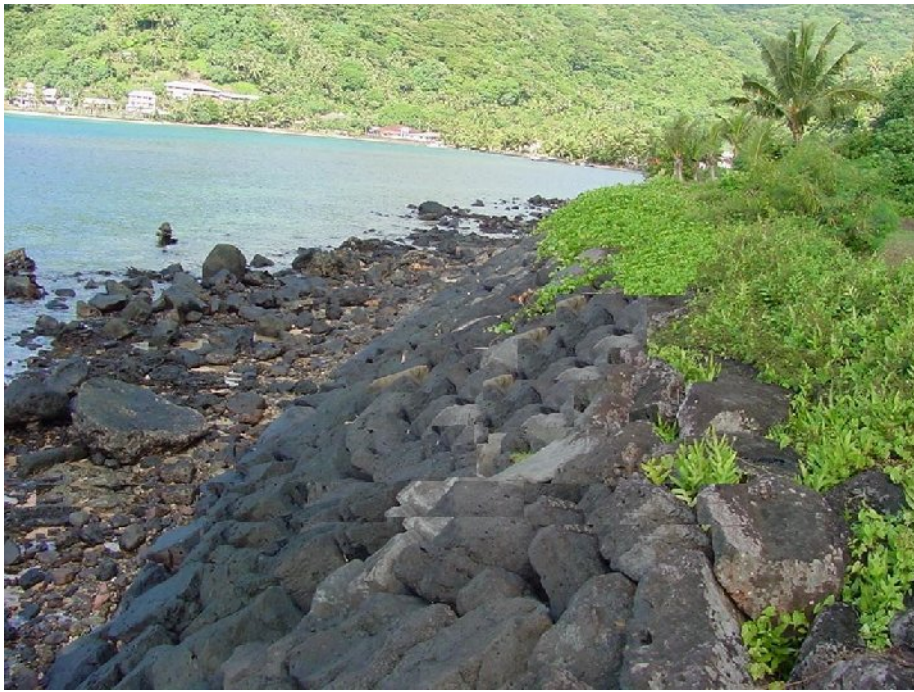
The definition of the revetments and seawalls are taken as described in Baird 2003 report. The revetment is defined as a sloped facing of stone, concrete or other durable materials build to protect a scarp or embankment against erosion by wave action. The seawall is a vertical or near vertical shoreline protection work protection works separating the lands and the water areas.

Picture 6.2.: Rock armour on the shoreline

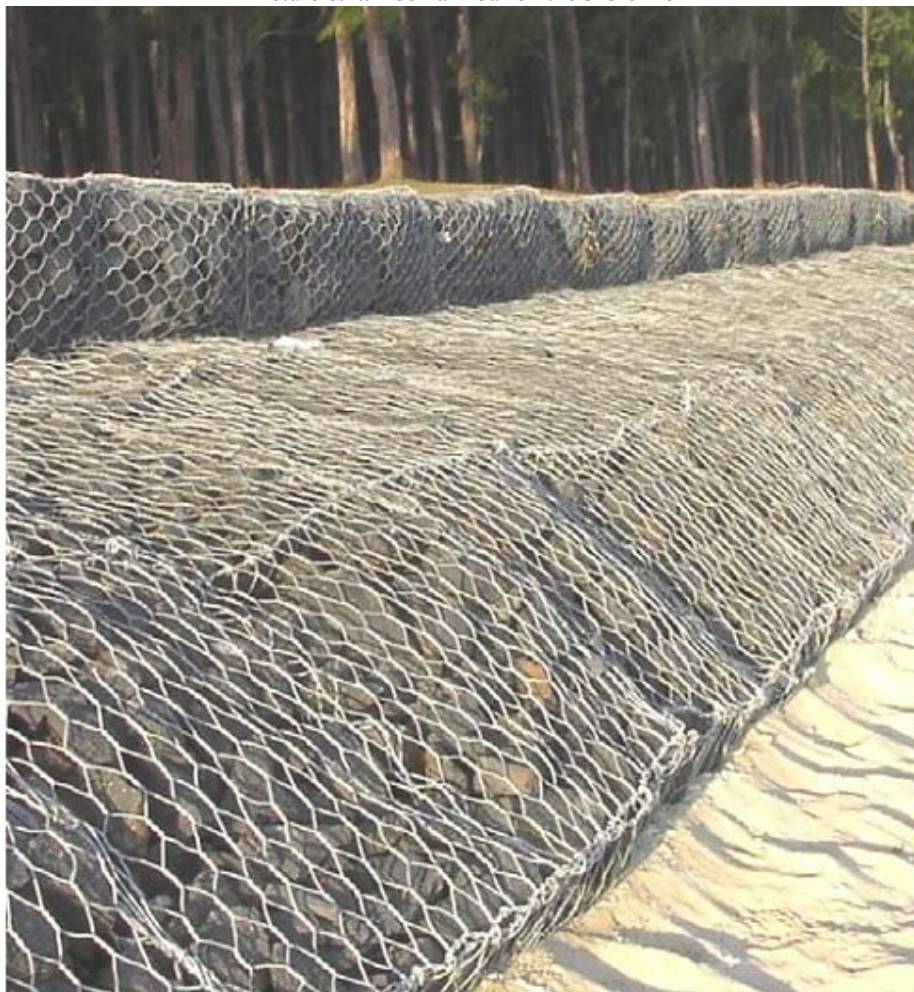
Picture 6.3.: Gabion rock revetment. Source: Baird 2003

- The revetment would cover a good portion of the existing sand beach and as such would considerably degrade the immediate marine environment.
- The revetment would be aesthetically and visually unsuitable for the proposed site.
- The lifetime of the revetment is limited especially for the sloping gabion and requires regular maintenance
- The costs involve in the construction and in terms of materials needed are very high as compared to the proposed structure.
- The revetment could cause erosion to the neighbouring site to the west.
